# Causes and Countermeasures:

The Accident at TEPCO's Fukushima Nuclear Power Stations

Deputy Director General, Nuclear Safety Regulation Reform  
Ministry of Economy, Trade and Industry (METI)

March, 2012

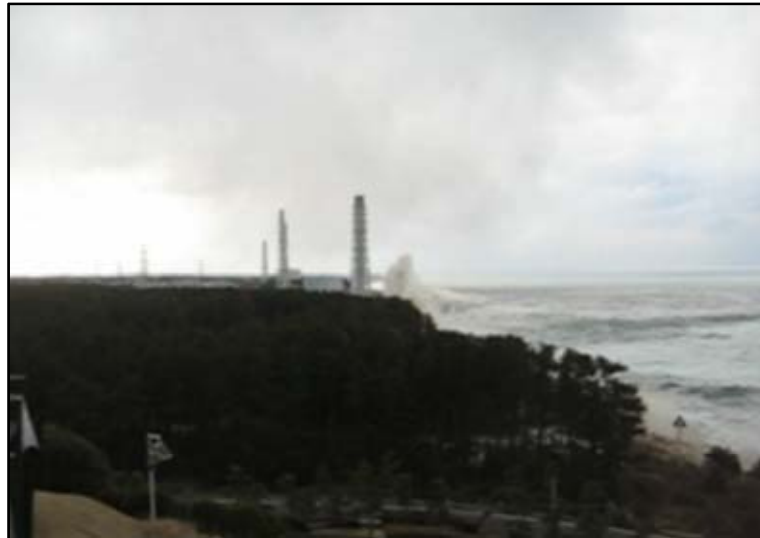
The moment when tsunami attacked Fukushima Dai-ichi NPS (source: TEPCO)

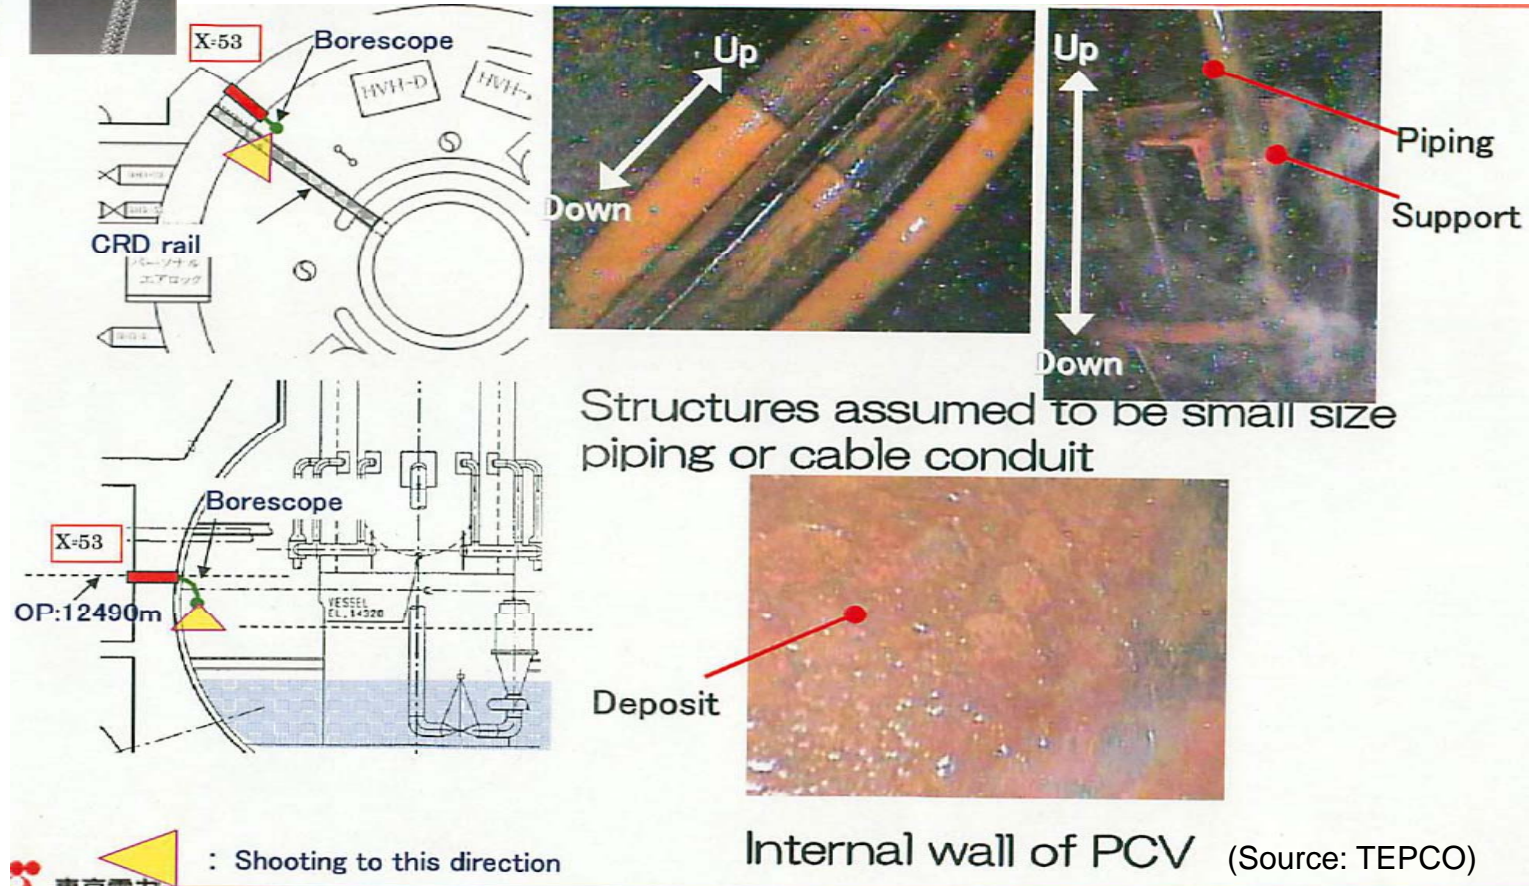
< Photos inside the PCV of Unit 2 >

- Photos were taken inside the PCV by an industrial endoscope (length:10m).

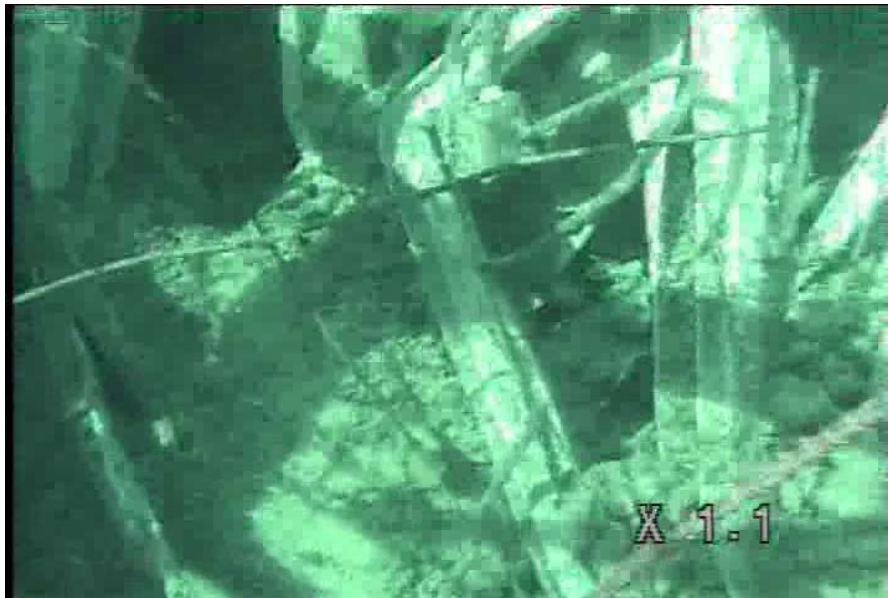
Situation of SFP of Unit 3

- Unit 3: Due to Much debris from the explosion of the reactor building the status of the fuel can not be confirmed.
- Unit 4: The fuel is usually confirmed to be stored in the racks and not severely damaged.

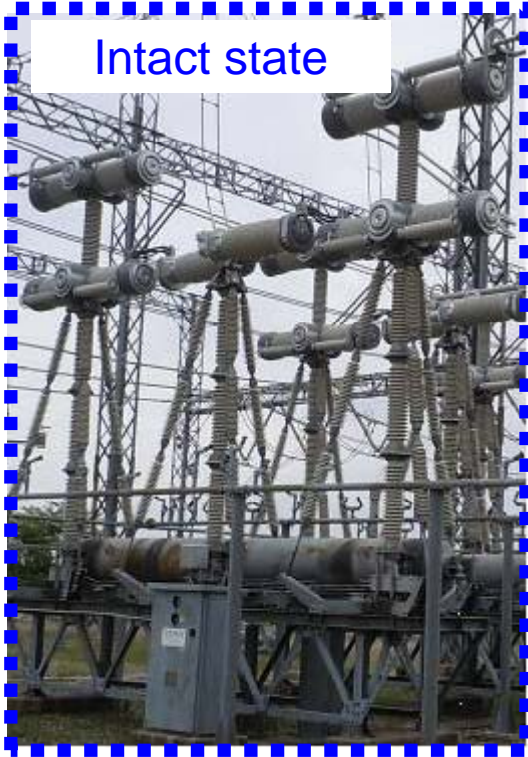
Intact state

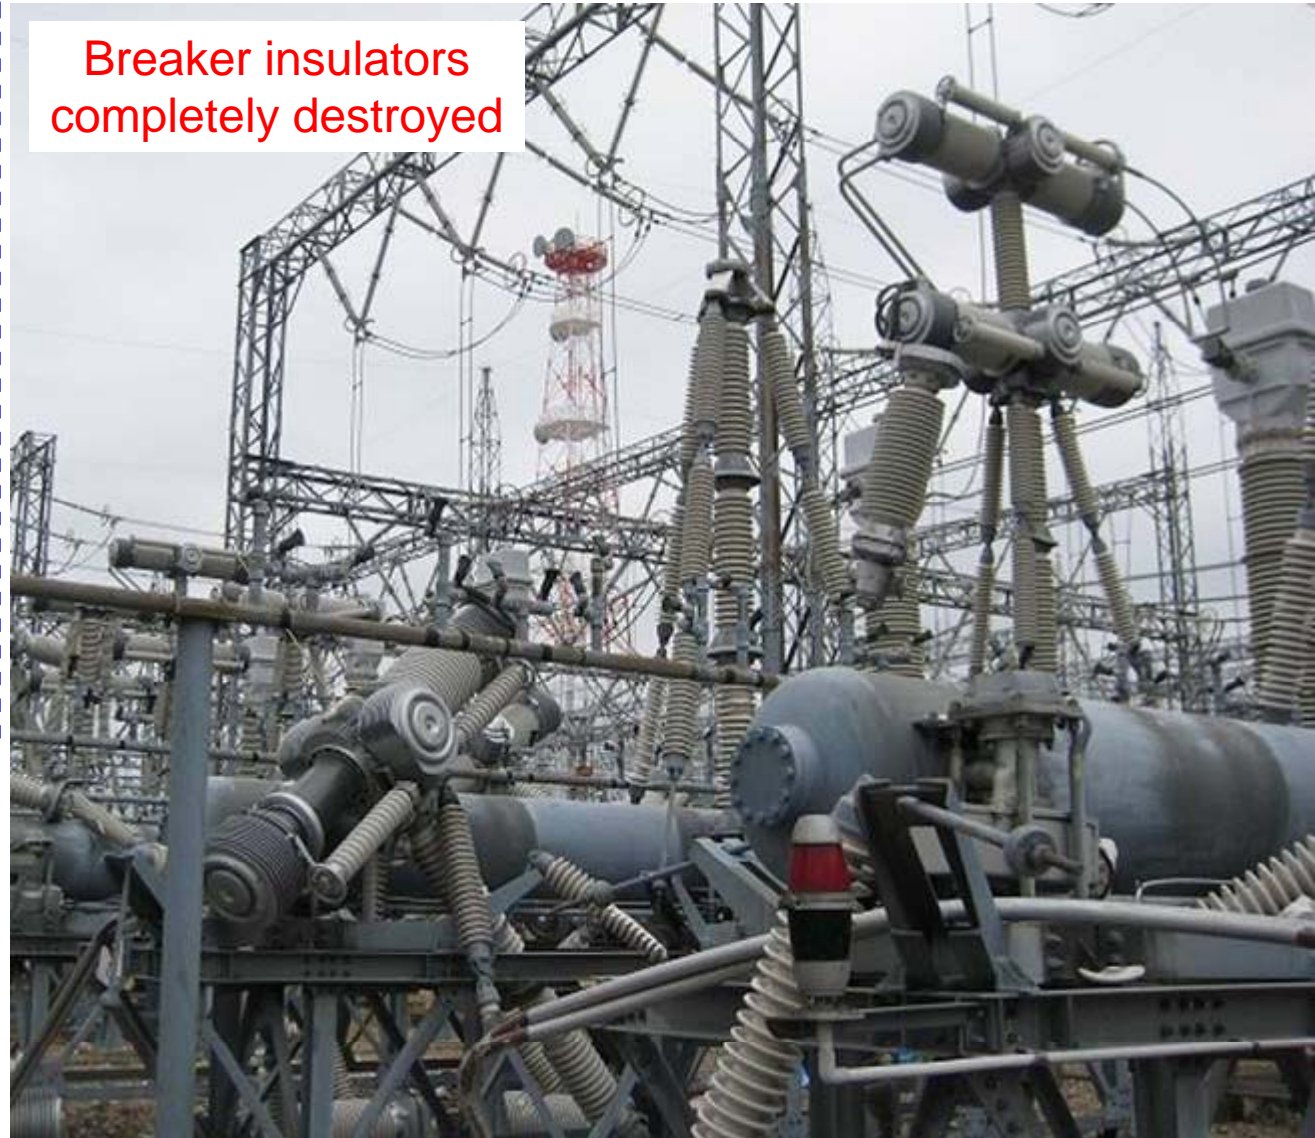
[275kV air blast breaker: completely destroyed]

Breaker insulators completely destroyed

## Countermeasure 2 Improve earthquake resistance of substation

( Example: Using gas insulated equipments and high-strength isolators )

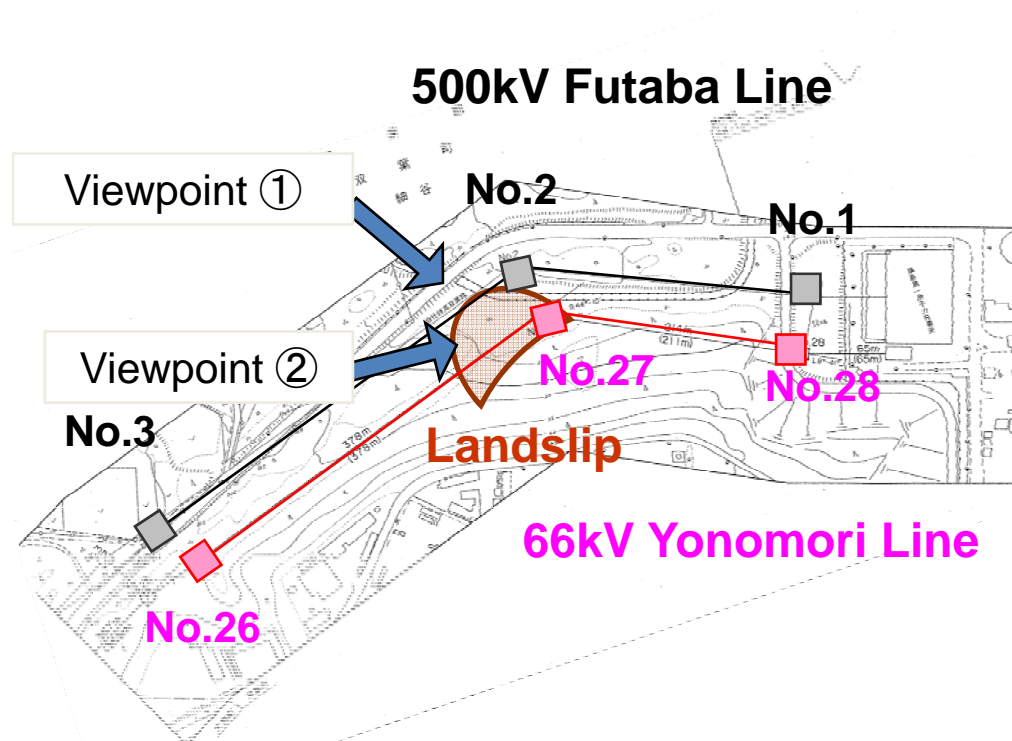
Collapse of pylon due to landslide (Yonomori Line no. 27)

- Temporary restoration by circuitous route on Mar. 18 (Reroute to Futaba Line no. 2)
- Futaba line was changed to 66kV (completed in July)

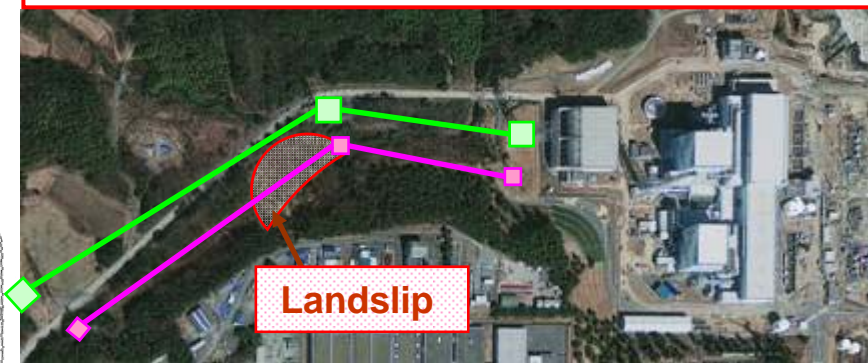
Landslip on slope

Landslip on slope (viewpoint ①)

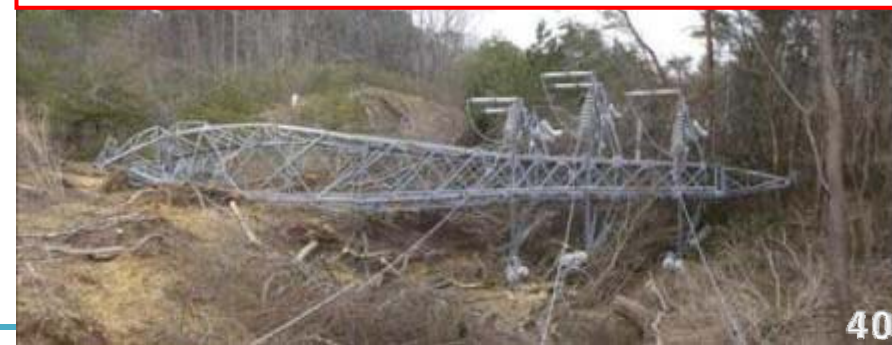
Collapse of Pylon (viewpoint ②)

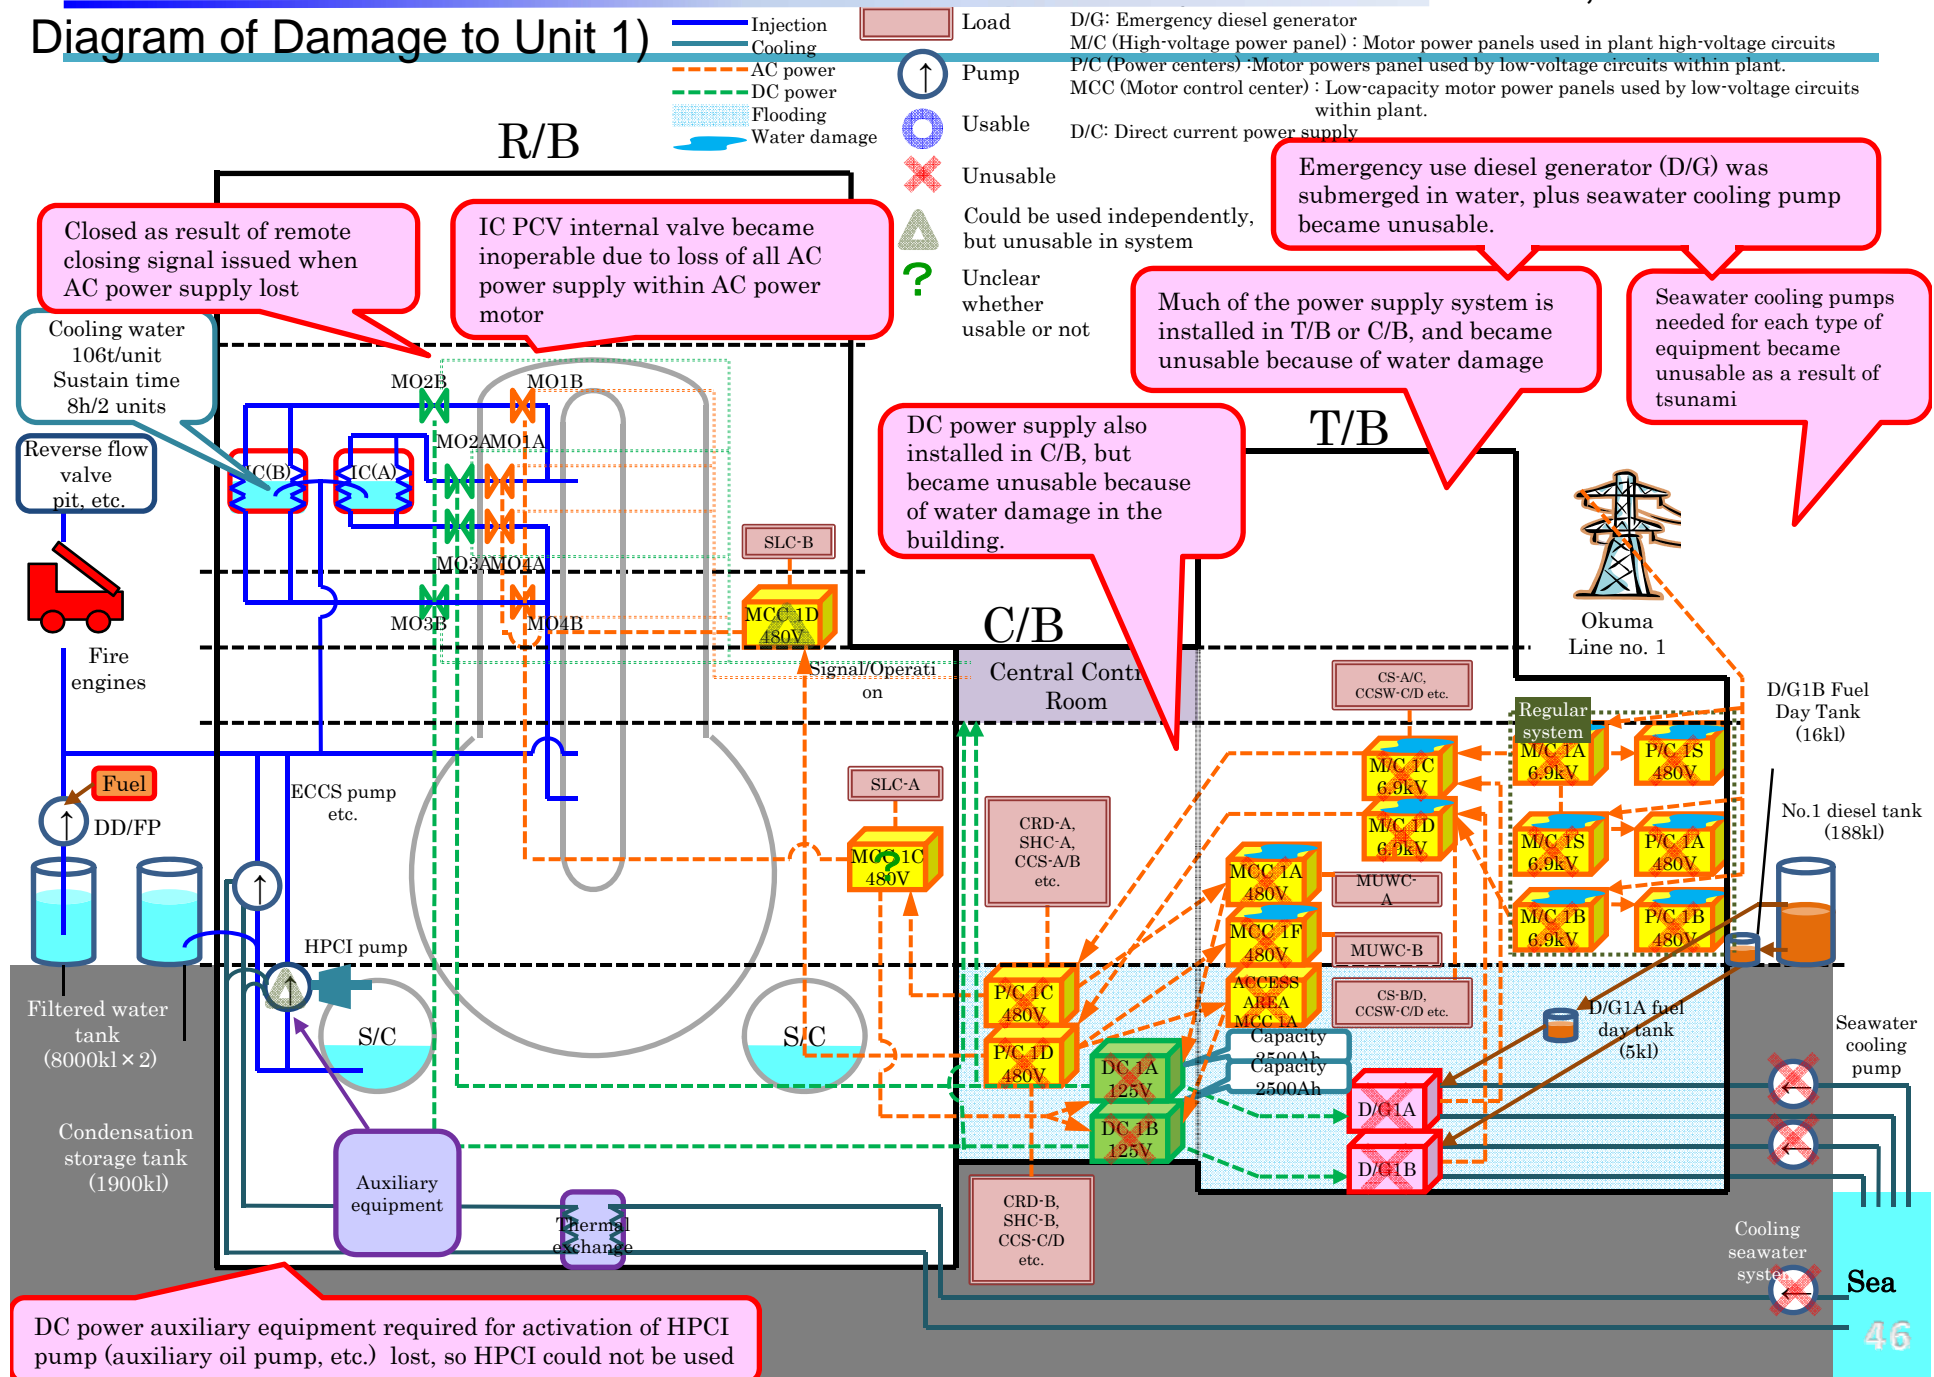
- Most of the power supply equipment installed on the basement floors of the turbine buildings (T/Bs) and the control buildings (C/Bs) near the ocean were damaged due to flooding or water damage.

The emergency diesel generators (D/Gs) lost function due to flooding or water damage. Even intact D/Gs could not supply power because supporting equipment such as DC power supply, sea water pumps, high-voltage switch boards (M/Cs), power centers (P/Cs) and etc. lost function due to flooding or water damage.

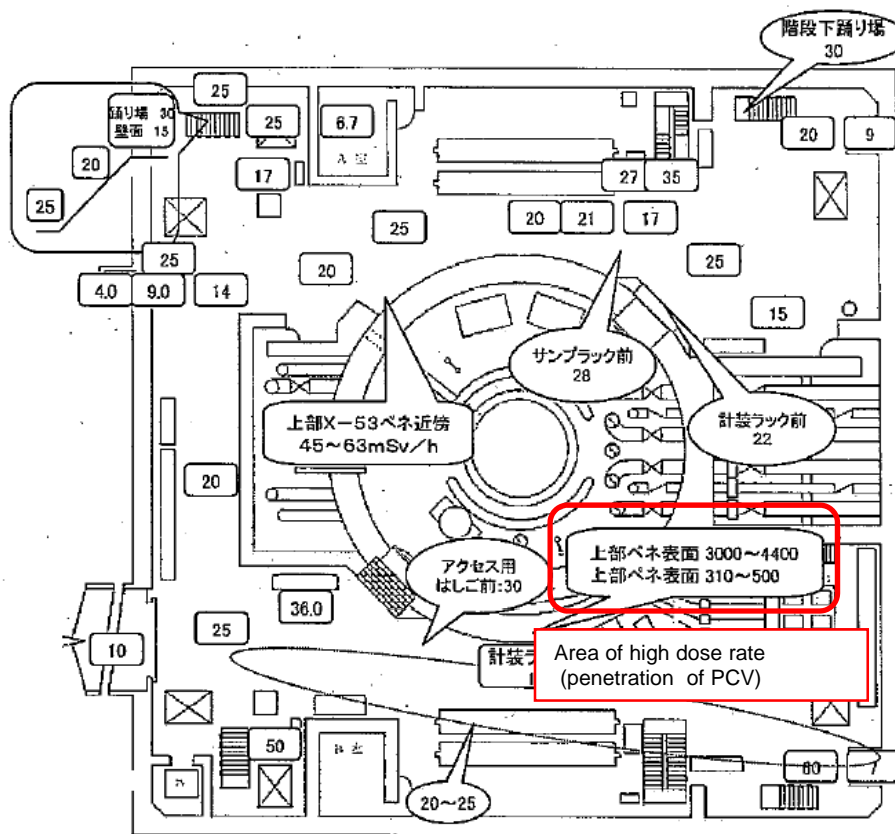
1<sup>st</sup> floor of the Unit 2 reactor building

- There are several places where a locally high dose rate is detected.

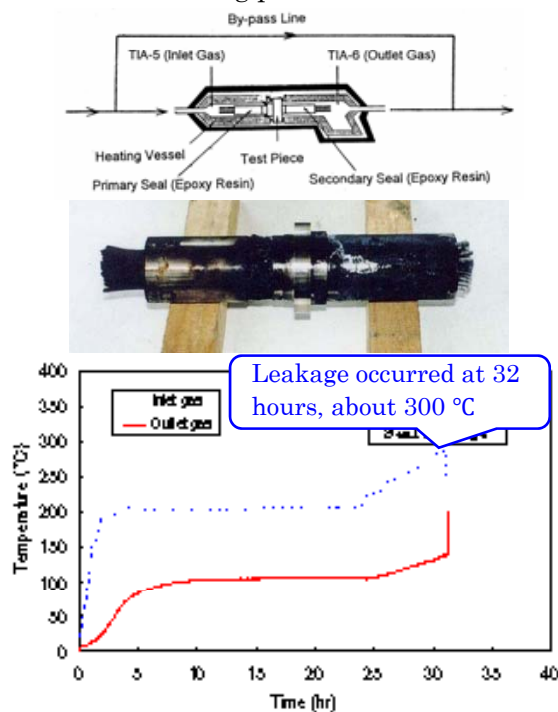
< wiring penetration >

- Experiments show leakage can occur from the seal materials of wiring penetration and flange gaskets even under pressure of 0.4~1MPa if heated over 250°C.
- PCVs' temperature were estimated over 500°C for Unit 1, about 280°C for Unit 2, and over 400°C for Unit 3 by MELCOR analysis.
- According to JNES experiments, the leak rate can reach 100%/day at a containment pressure of 0.2MPa, taking only the deterioration of the top flange gasket into account, which is consistent with the situation of large-scale vapor release at the accident.

## Countermeasure 19 Prevention of the damaging of PCV top-head flange caused by overheating

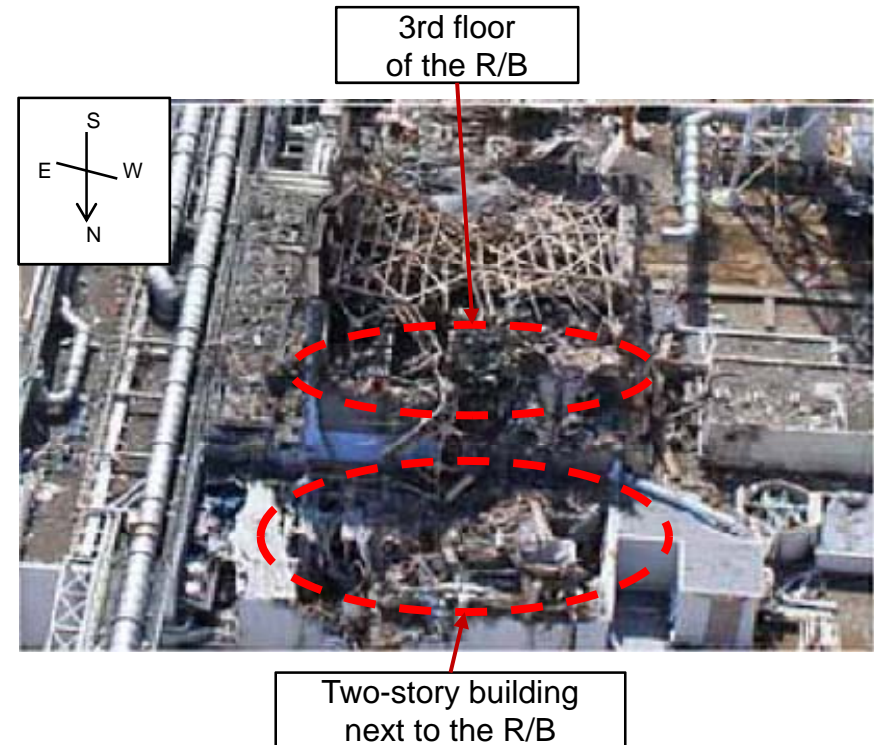
- For Unit 3, an analysis result of the explosion and the actual damage state show probability of hydrogen leakage through hatches and/or penetrations to 1st floor of the reactor building.

The 3<sup>rd</sup> floor of Unit 3 R/B and the top of a two-story building next to the R/B have also been damaged.
