# Causes and Countermeasures:

The Accident at TEPCO's Fukushima Nuclear Power Stations

Deputy Director General, Nuclear Safety Regulation Reform  
Ministry of Economy, Trade and Industry (METI)

March, 2012

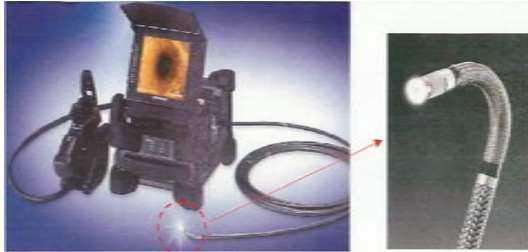
<Industrial endoscope>

- Photos were taken inside the PCV by an industrial endoscope (length:10m).

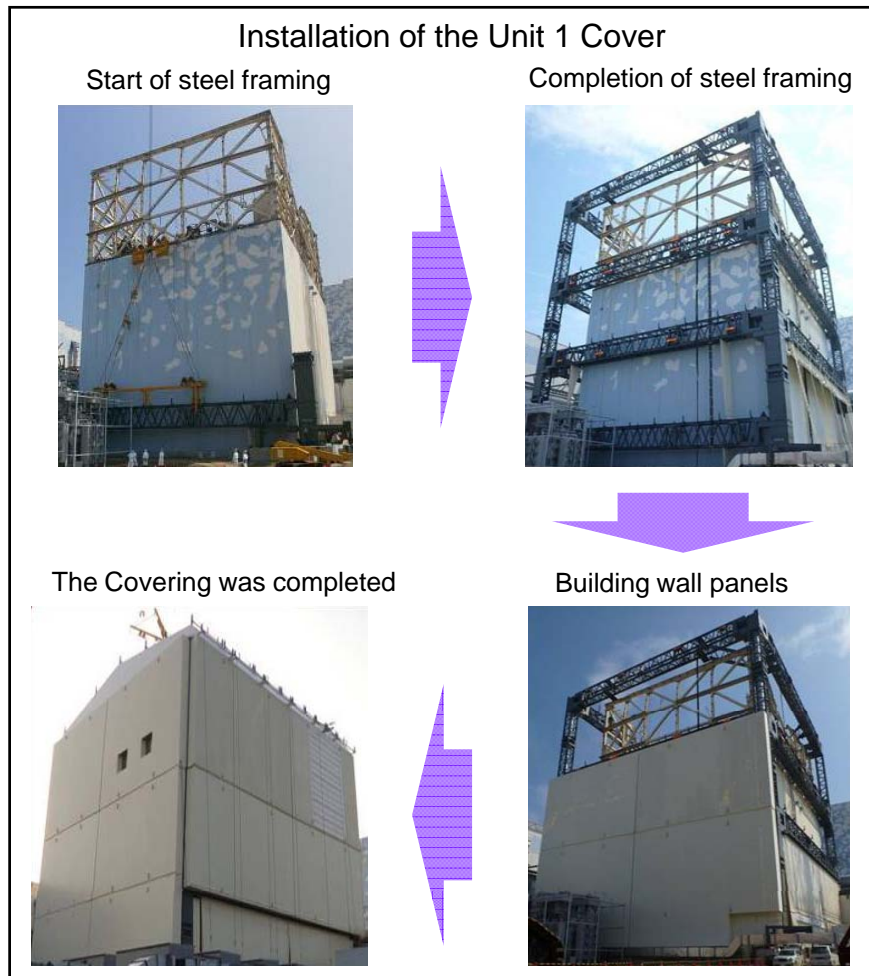
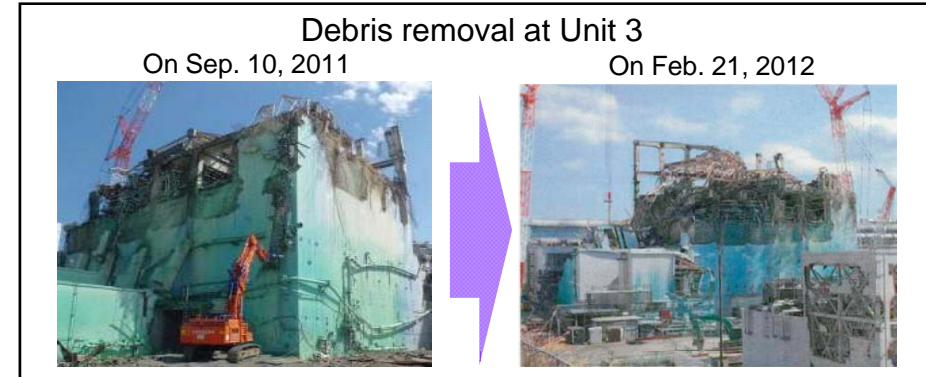
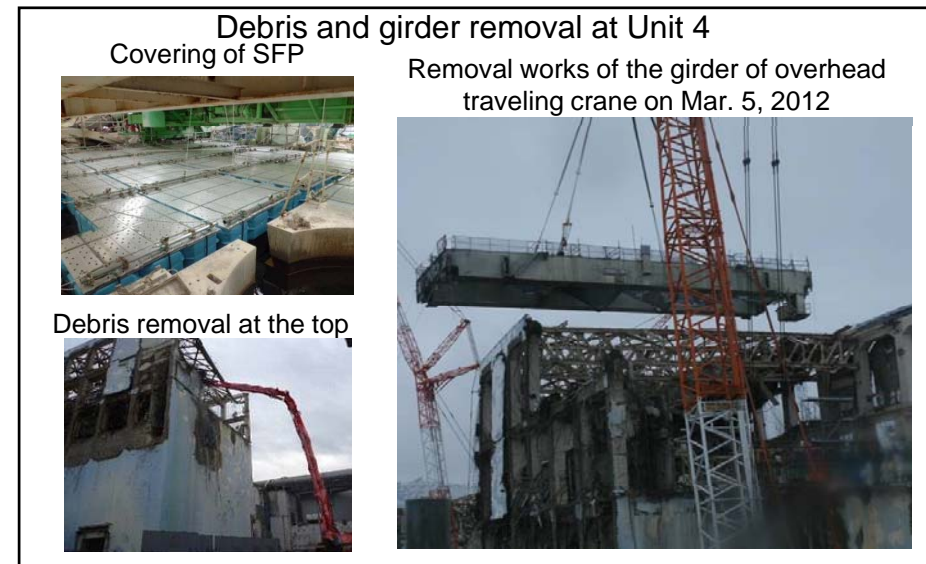
- A cover was installed in the Unit 1 building to restraint release of radioactive materials.
- Rubble is being removed from the upper part of the reactor buildings for Units 3 and 4 before installation of the covers.

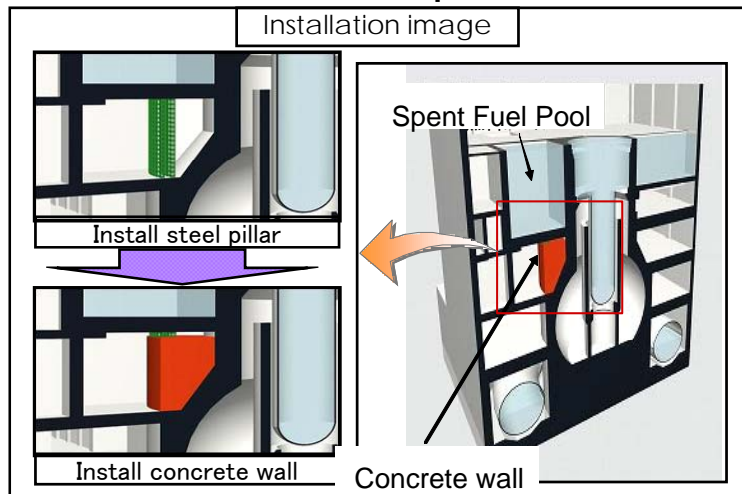
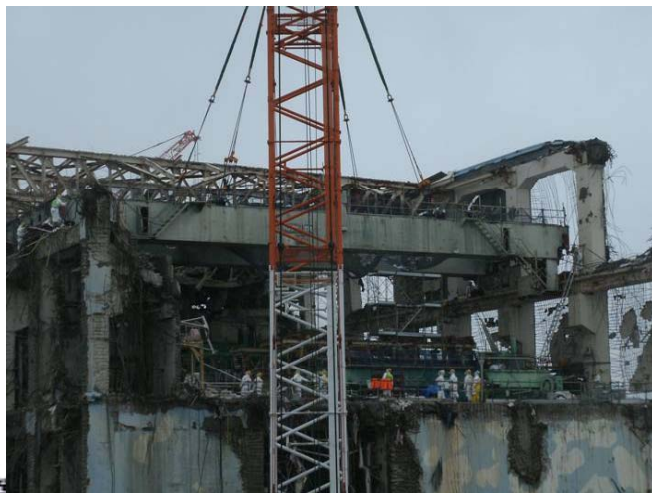
- It has been confirmed that the seismic resistance is sufficient without any reinforcements.
- Nevertheless, support structures at the bottom of the pool has been installed in order to further improve the safety margin.

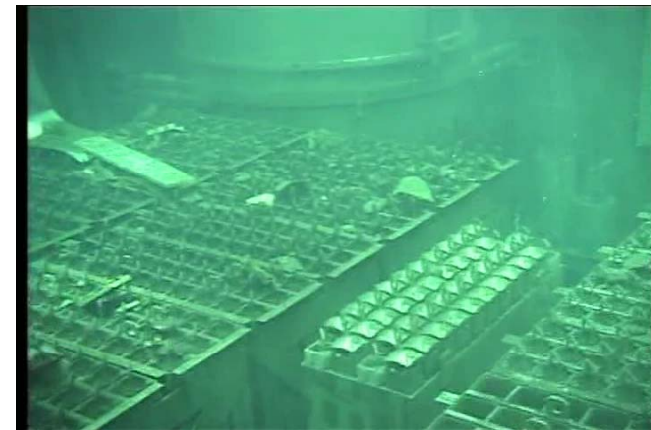
Situation of SFP of Unit 3

- Unit 3: Due to Much debris from the explosion of the reactor building the status of the fuel can not be confirmed.
- Unit 4: The fuel is usually confirmed to be stored in the racks and not severely damaged.

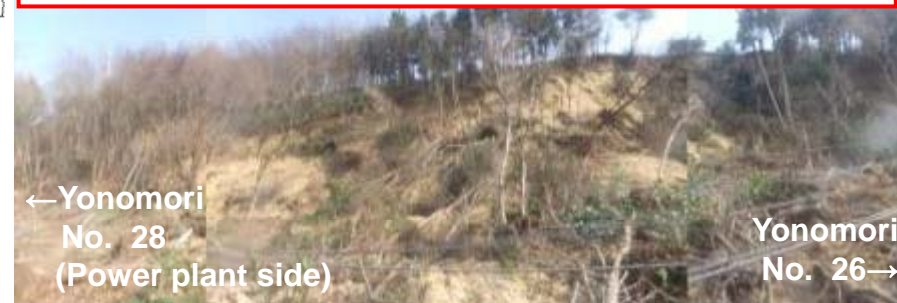
Landslip on slope (viewpoint ①)

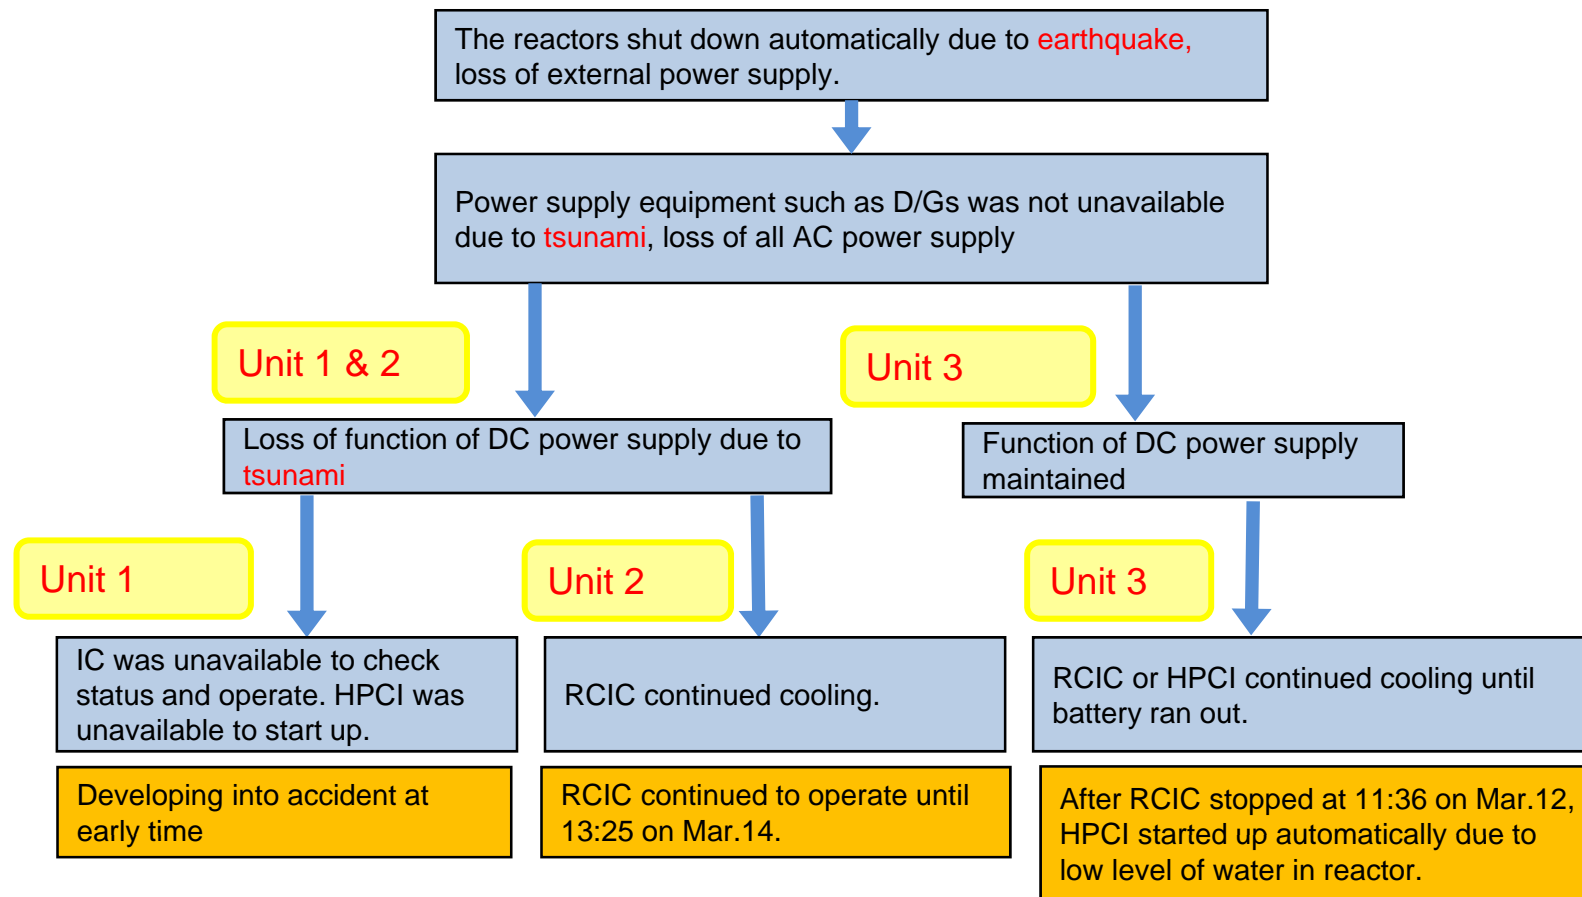
# Relation between of Power Supply and Cooling Systems

- Unit 1: Cooling systems became uncontrollable due to loss of all power supply in the early stage.
- Unit 2: All power supply was lost. RCIC continued cooling.
- Unit 3: RCIC and HPCI continued cooling until D/C power supply ran out.

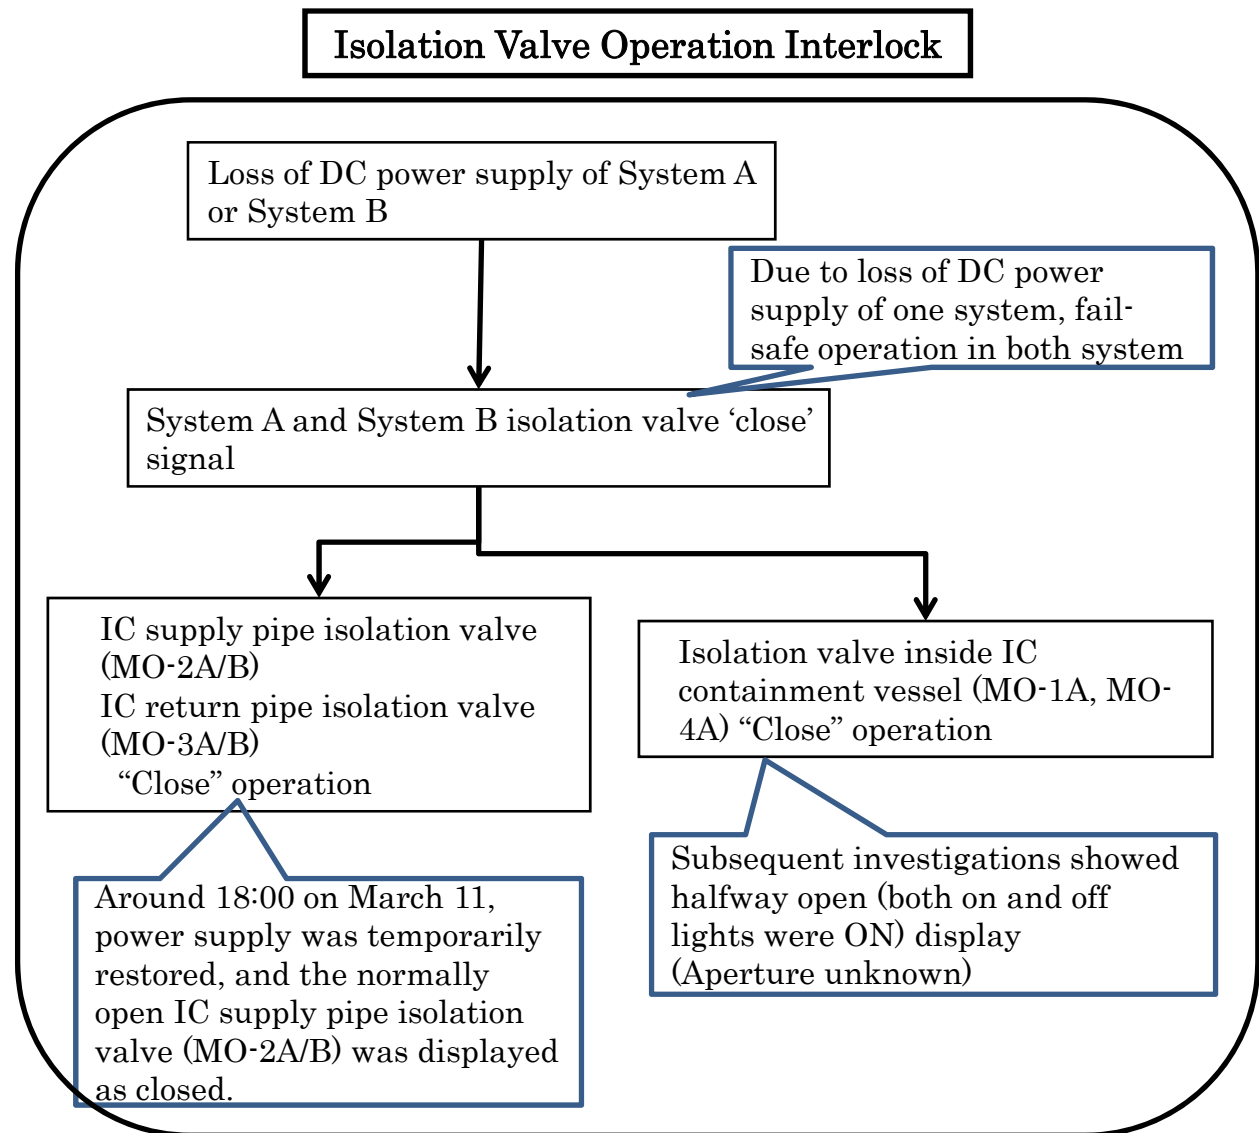
# Operating Conditions of Isolation Condenser (IC) of Unit 1

- Due to loss of DC power supply after tsunami, the indication of the valve status (open or close) went off, and the IC became uncontrollable.
- Due to loss of DC power supply, the interlock of the isolation valve in fail-safe mode closed the IC valves.

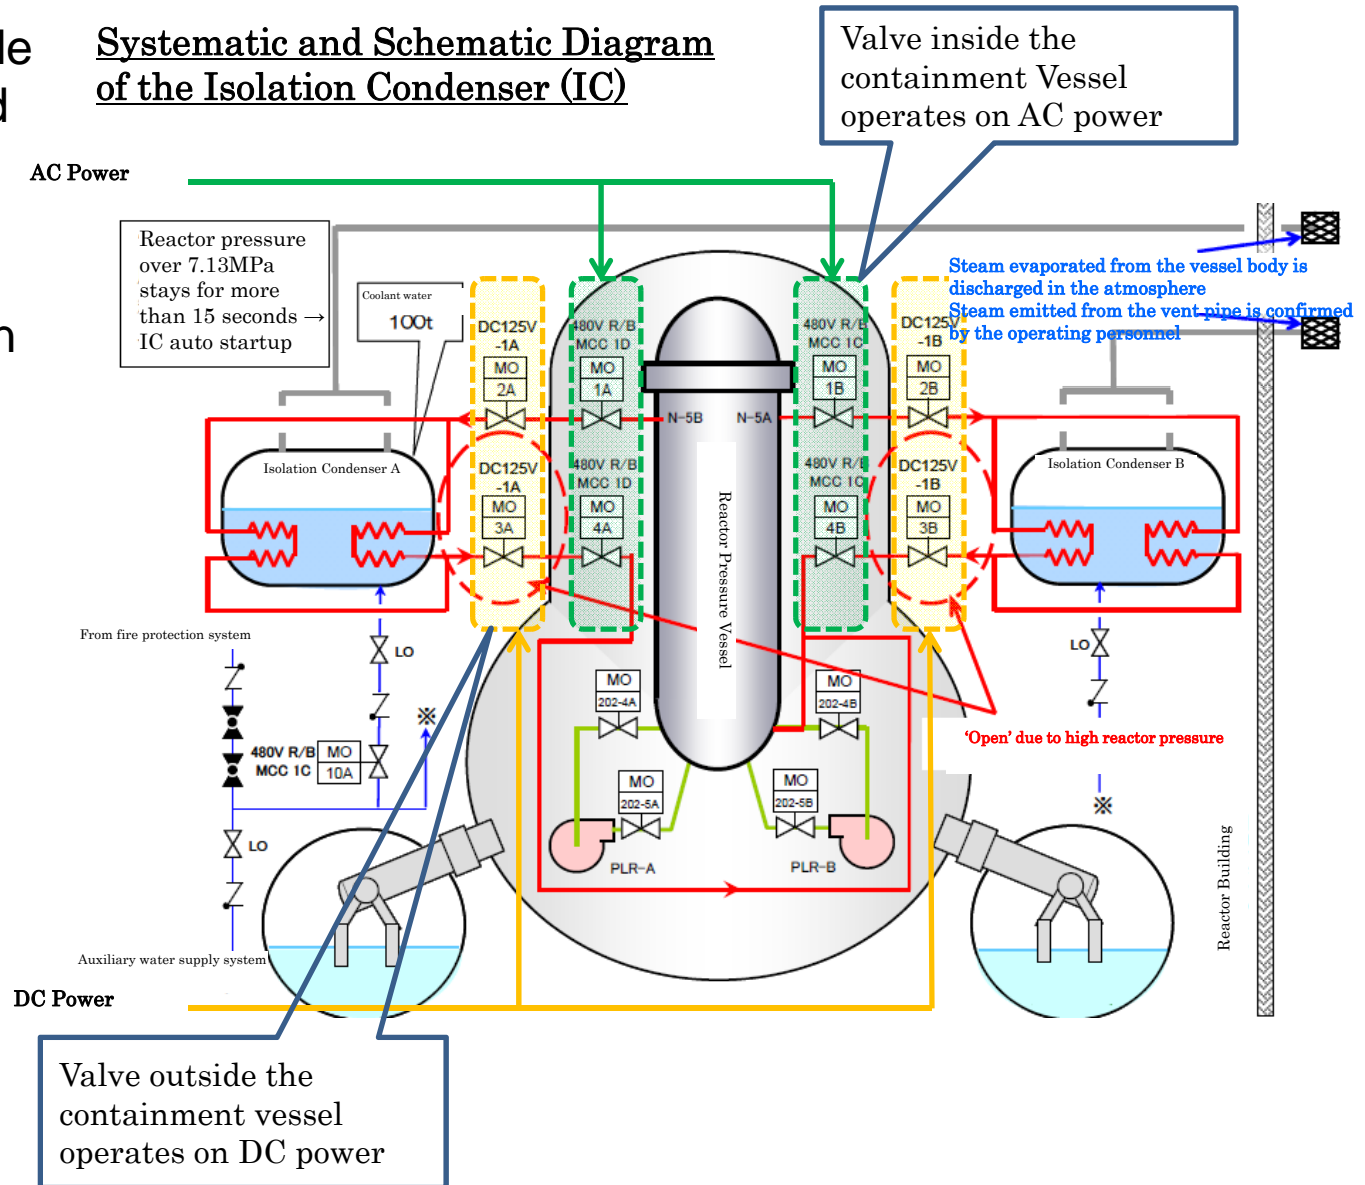
## Systematic and Schematic Diagram of the Isolation Condenser (IC)

# Operating Conditions of the Isolation Condenser (IC) of Unit 1 (cont.)

- Since the valves inside the PCV are operated with AC power, both status-check and operation were impossible even when the DC power supply was temporarily restored.
- The status of the IC was misunderstood.

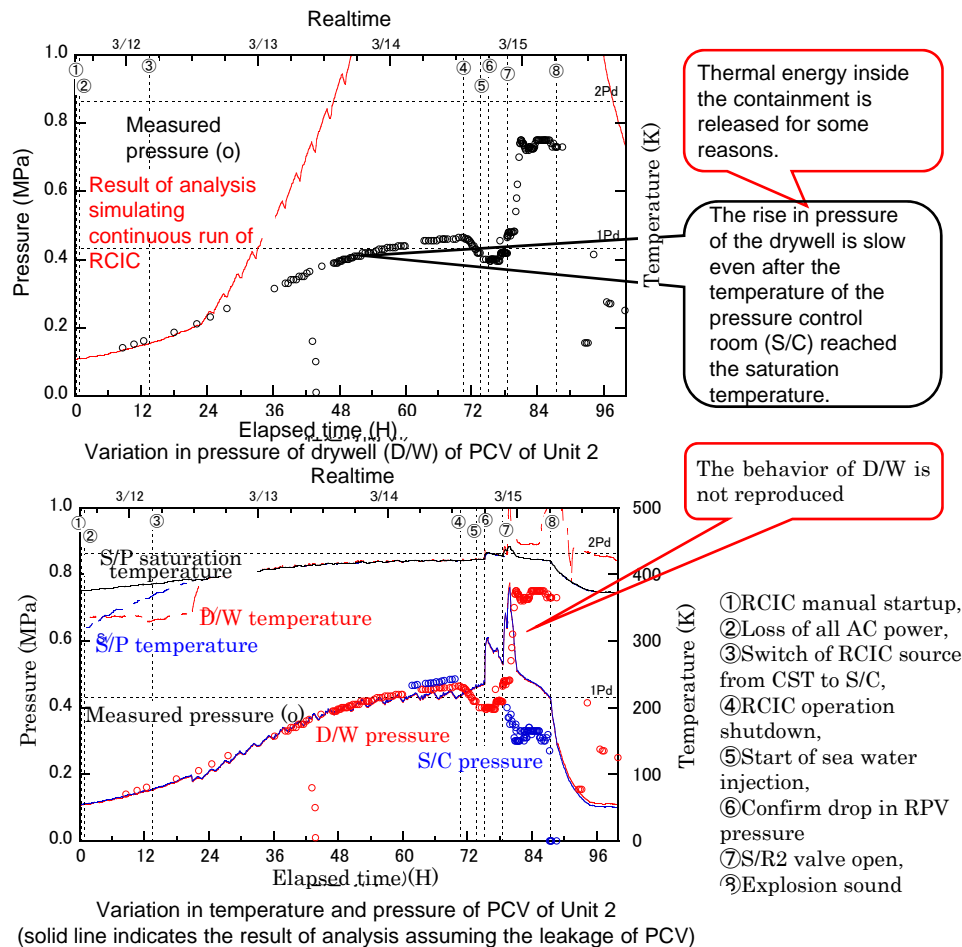
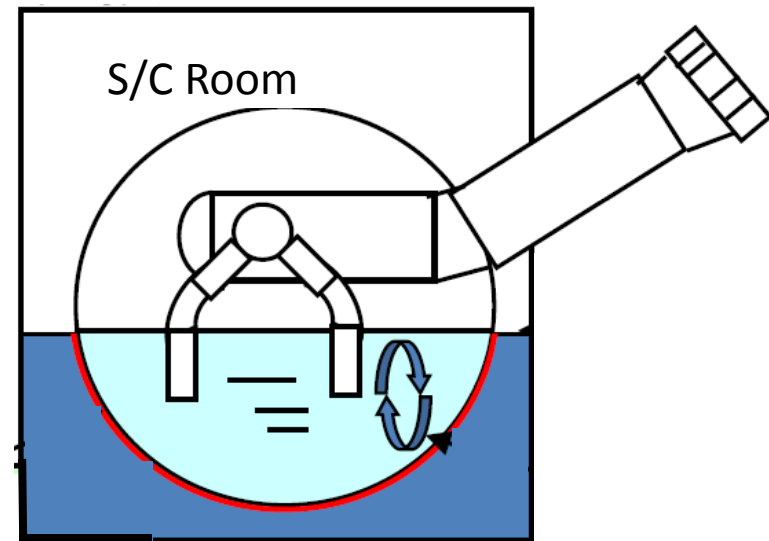
## Newly assumed condition

# Analysis of Condition of PCV of Unit 2

- In the analysis in June, 2011, PCV leakage was assumed in order to explain slow rise of PCV pressure until Mar. 14.
- It is newly assumed that sea water intruded into the S/C room and contributed to the slow rise of PCV pressure.

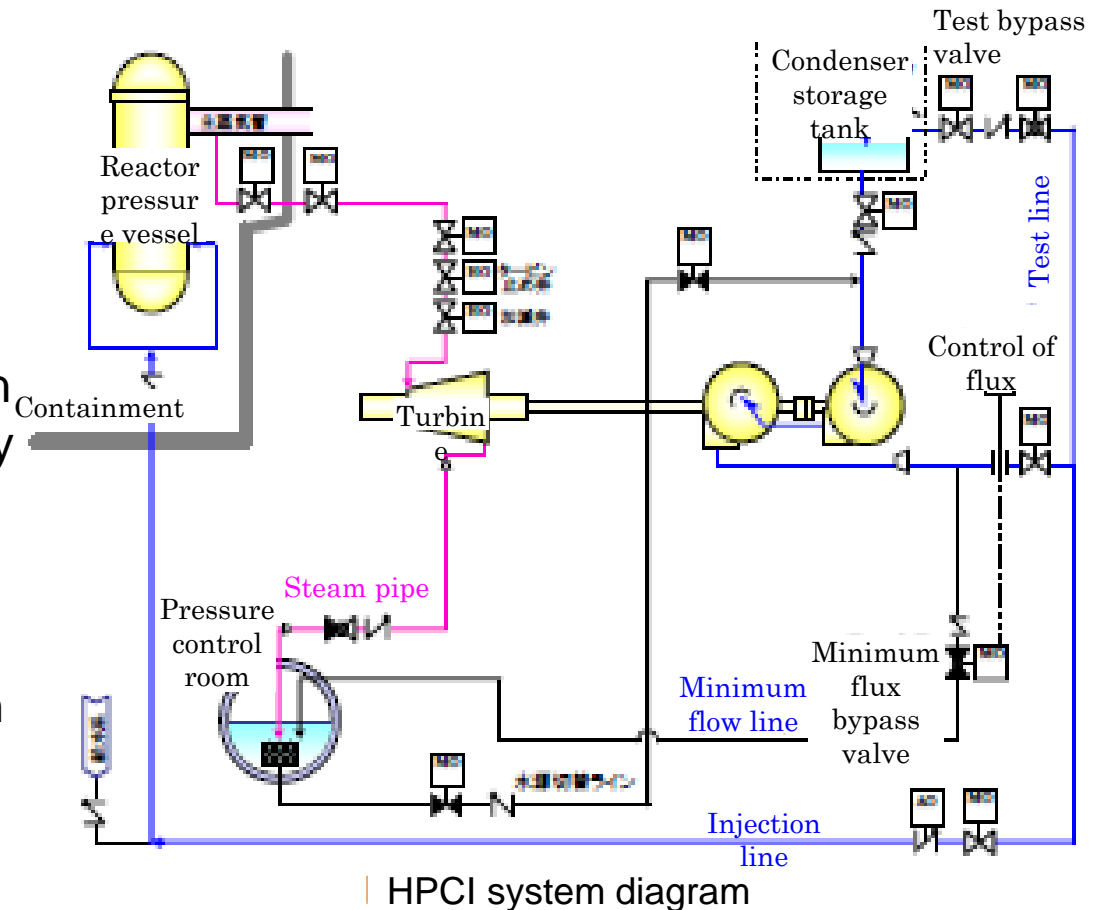
## Operating Conditions and Causes of shut down of High Pressure Coolant Injection (HPCI) System of Unit 3

- Situation of HPCI of Unit 3,
  - (1) The amount of flow was adjusted using test lines.
  - (2) Minimum flow line was closed.
  - (3) The HPCI was manually shut down when the reactor pressure dropped below 1MPa.
- This decision on manual shut down was made only by a worker on duty and some other staffs without consulting senior managers.
- Because the SRV could not be opened due to battery depreciation after the HPCI shut down, RPV pressure rose. And alternative low pressure coolant injection by fire truck did not work either.

Water level went down, and the core was exposed

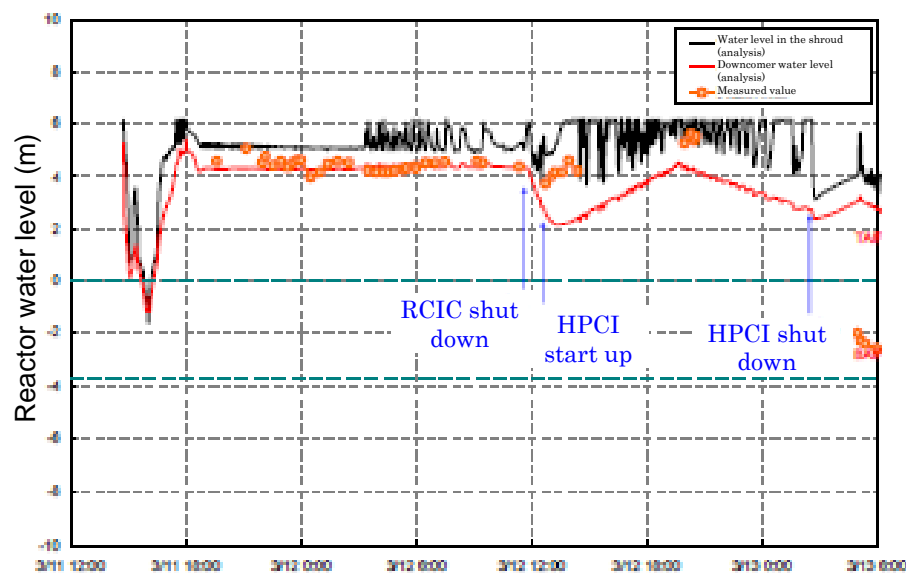
Time variation of reactor water level of Unit 3

## Operating Conditions and Causes of shot down of HPCI System of Unit 3 (cont.)

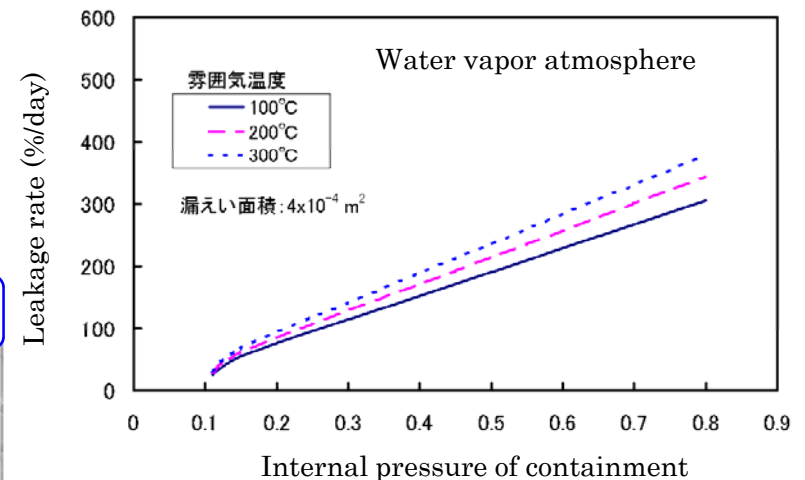
### Estimation of leakage rate at the top flange gasket of deterioration due to over-heating

## Possibility of Containment Damage due to Over-pressurization and/or Over-heating (over-Heating Damage)

- Experiments show leakage can occur from the seal materials of wiring penetration and flange gaskets even under pressure of 0.4~1MPa if heated over 250°C.
- PCVs' temperature were estimated over 500°C for Unit 1, about 280°C for Unit 2, and over 400°C for Unit 3 by MELCOR analysis.
- According to JNES experiments, the leak rate can reach 100%/day at a containment pressure of 0.2MPa, taking only the deterioration of the top flange gasket into account, which is consistent with the situation of large-scale vapor release at the accident.

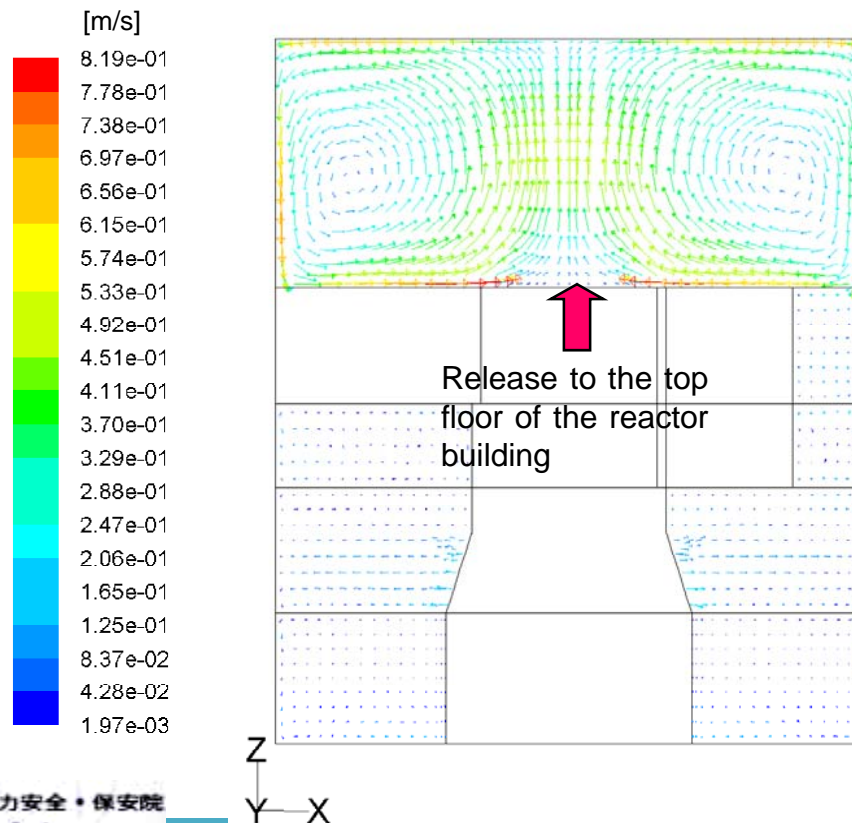
- It is highly possible that the leakage occurred at the top flange because the explosion occurred on the top floor (5F) in Unit 1.
- The released hydrogen into 5F of the reactor building accumulated mainly in 5F. (The hydrogen density is about 20% in the case of 400kg hydrogen release.)

Behaviors of hydrogen gas assuming the release of hydrogen of 400kg from the floor surface of the top floor of the reactor building. (flow field)

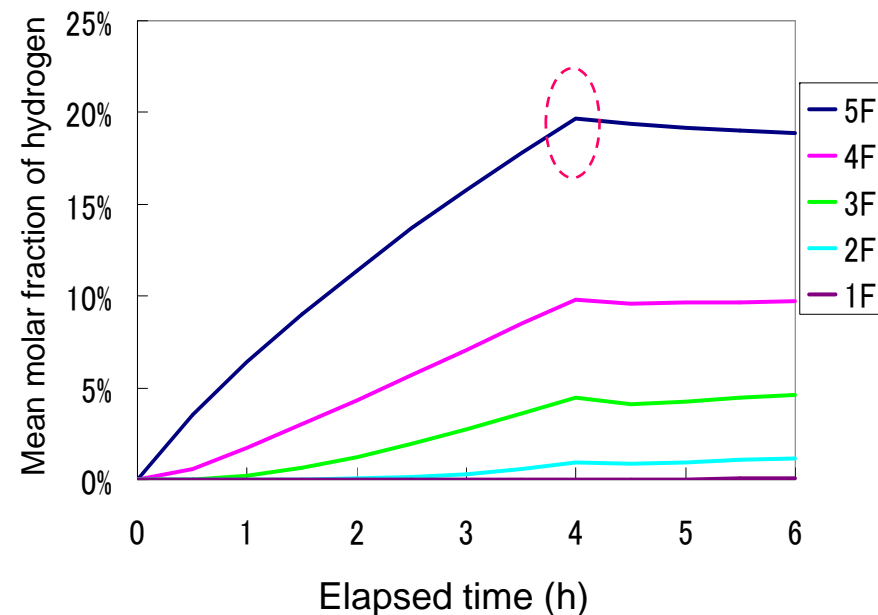
Time variation in hydrogen density in the reactor building assuming the release of hydrogen of 100kg/h for 4 hours.

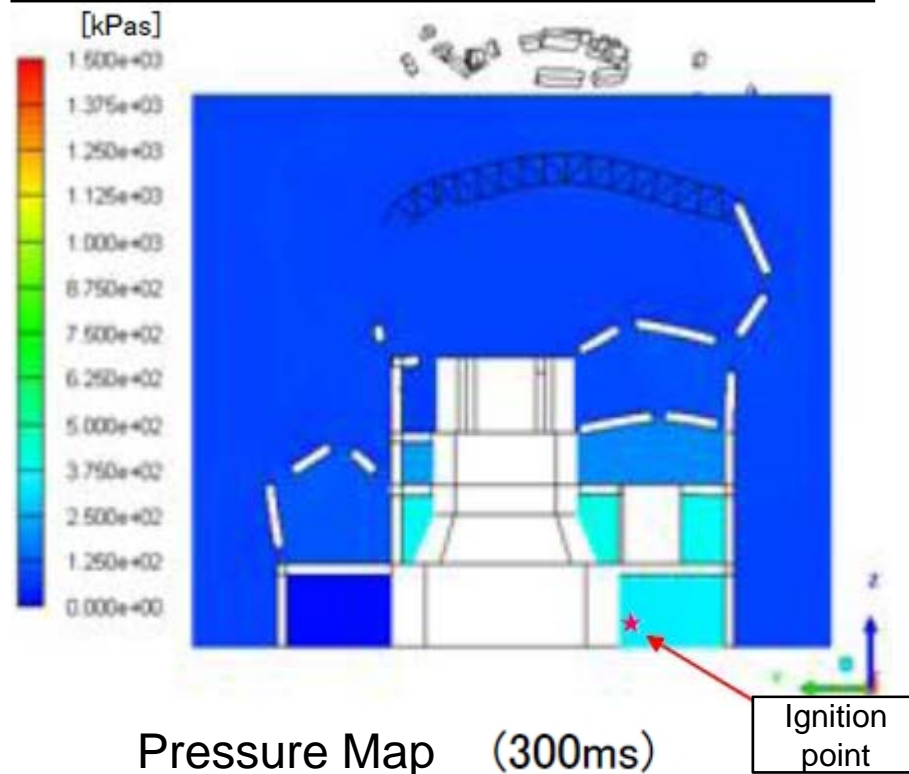
- For Unit 3, an analysis result of the explosion and the actual damage state show probability of hydrogen leakage through hatches and/or penetrations to 1st floor of the reactor building.

Assuming 1,000kg H<sub>2</sub> leakage from PCV to 1<sup>st</sup> floor of R/B, an analysis (using AUTODIN) results in damages not only on the upper part of R/B but also other parts including surrounding buildings

The 3<sup>rd</sup> floor of Unit 3 R/B and the top of a two-story building next to the R/B have also been damaged.

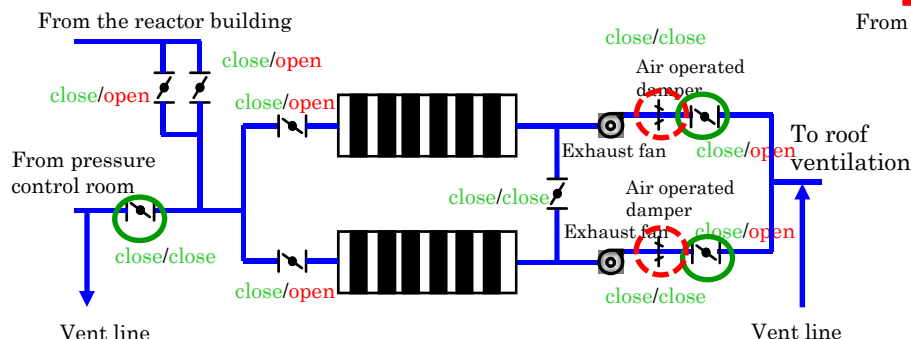
## Unit 1

- To isolate SGTS at the time of PCV vents, the outlet valves of SGTS must be closed according to the operational procedure. But the outlet valves of SGTS of Unit 3 were not isolated. Those of Unit 4 were thought not to be isolated as well.
- Because of the damper at the outlet for Units 1-3 which closes during loss of power, the flow into the building was supposed to be more prevented than Unit 4. Regarding Unit 3, there are no significant backflow in one direction into the building but it is difficult to deny the occurrence of backflow itself.

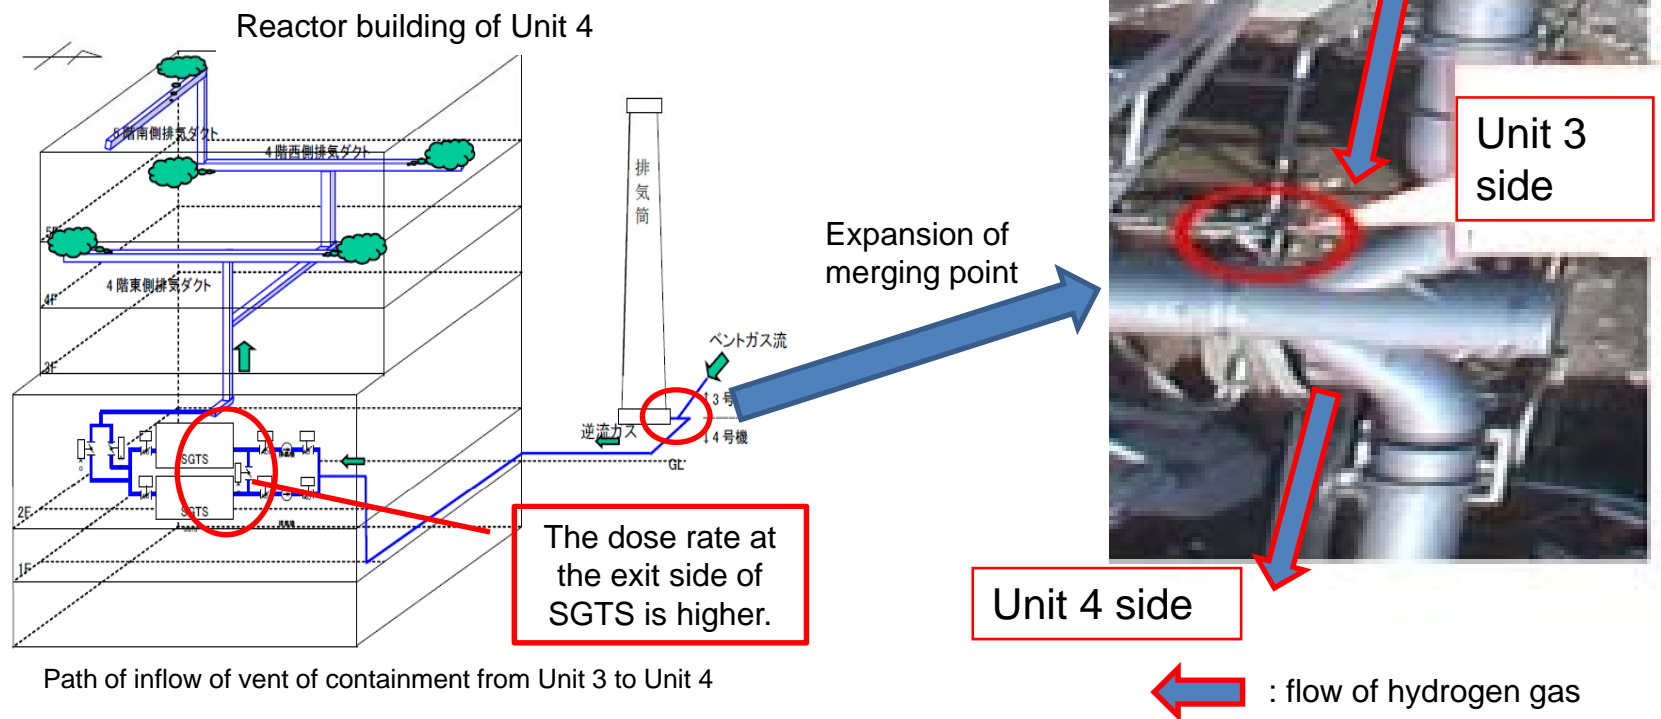
# Possibility of Back-flow to Building by PCV Vents (Unit 3⇒Unit 4)

- When hydrogen gas generated in Unit 3 backflows in SGTS of Unit 4, it will be released into the Unit 4 building via the building ventilation system.
- The floor and ceiling of the 4<sup>th</sup> floor of Unit 4 were deformed in the direction of expansion. As the contamination in the building of Unit 4 is lower than that in Units 1-3, it is supposed that it exploded due to hydrogen that flew into the building through filter, while explosions of Units 1 and 3 were caused by hydrogen leaked mainly from PCV.
